INDOOR AIR QUALITY ASSESSMENT

**Westminster Town Hall
3 Bacon Street
Westminster, Massachusetts**

Prepared by:
Massachusetts Department of Public Health
Center for Environmental Health
Emergency Response/Indoor Air Quality Program
November 2005

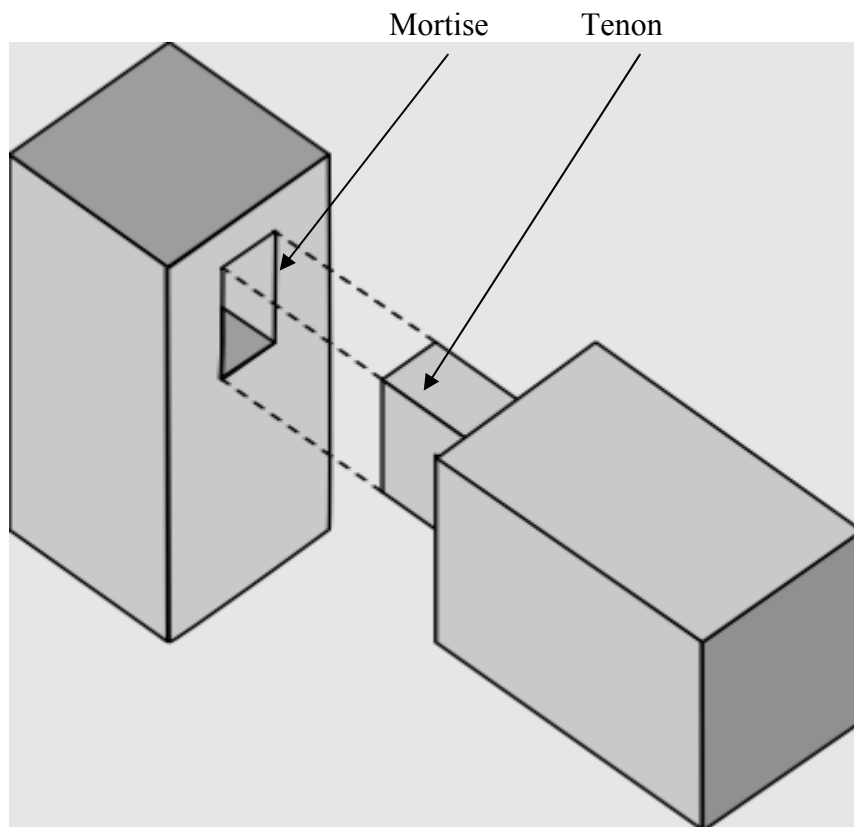
Figure 1

The town hall had undergone major structural refitting to preserve the structural soundness of the building. Substantial stabilization and repairs to portions of the roof and uppermost level were done in 2000. The topmost level contains a series of iron tie rods (Pictures 1 and 1A) that connect the floor/auditorium ceiling to the ridge beam of the roof. This design would transfer the weight of the floor/auditorium ceiling and materials on the floor (called load), which would pull downward on the roof peak. This load would then be transferred to the roof rafters, which would then push outward on the exterior wall of the building. In order to provide roof support, horizontal beams connected to the rafters were inserted into a vertical wooden beam (called and mortise and tenon joint)

(Figure 1) (Picture 2). The mortise and tenon joints were held in place by a metal strap wrapped around the vertical beam and nailed into the horizontal beam with metal spikes (Picture 3). In this fashion, the outward thrusting of the roof rafters would be arrested by these horizontal/vertical beams.

Mortise and Tenon Joint

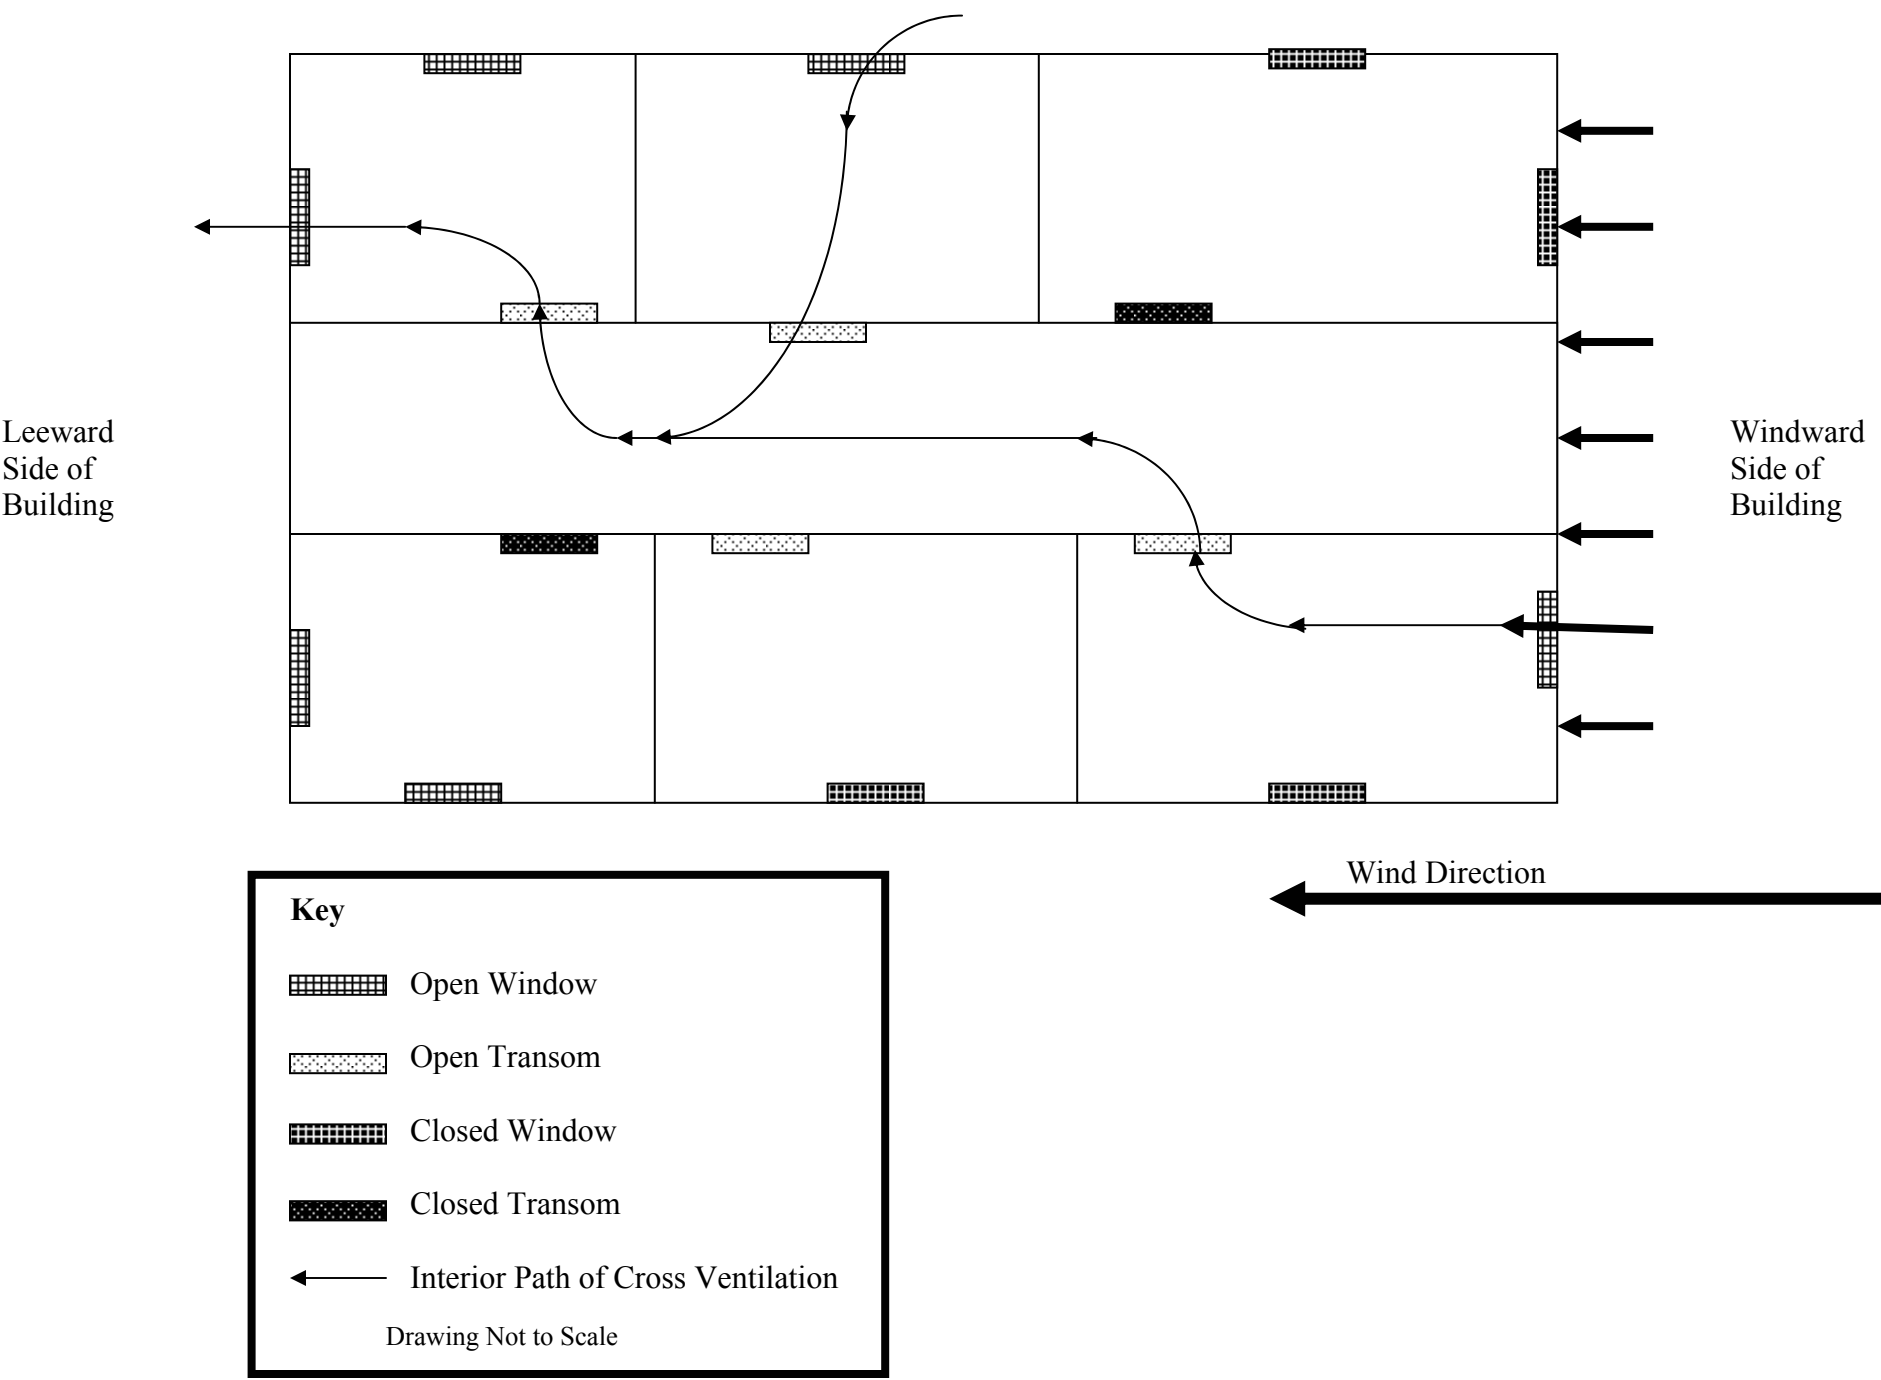
Figure 4

During summer months, ventilation is controlled by the use of openable windows. The building was configured in a manner to use cross-ventilation to provide comfort for building occupants. The building is equipped with windows on opposing exterior walls. Open hallway doors maintain a pathway for airflow. This design allows for airflow to enter an open window, pass through a room and an open door, enter the hallway, pass through the opposing open room door, into that room and exit the building on the leeward side (opposite the windward side) (Figure 3). With all windows and hallway doors open, airflow can be maintained in a building regardless of the direction of the wind. This system fails if the windows or doors are closed (Figure 4). Most hallway doors in the building were open during the assessment.

Inhibition of Cross Ventilation in a Building with Several Windows and Transoms Closed
